### 6.3.14. FNB Building.

Gauteng Provincial Government Precinct, Johannesburg, Gauteng - Heritage Guidelines for Interested and Affected Parties - July 2017.

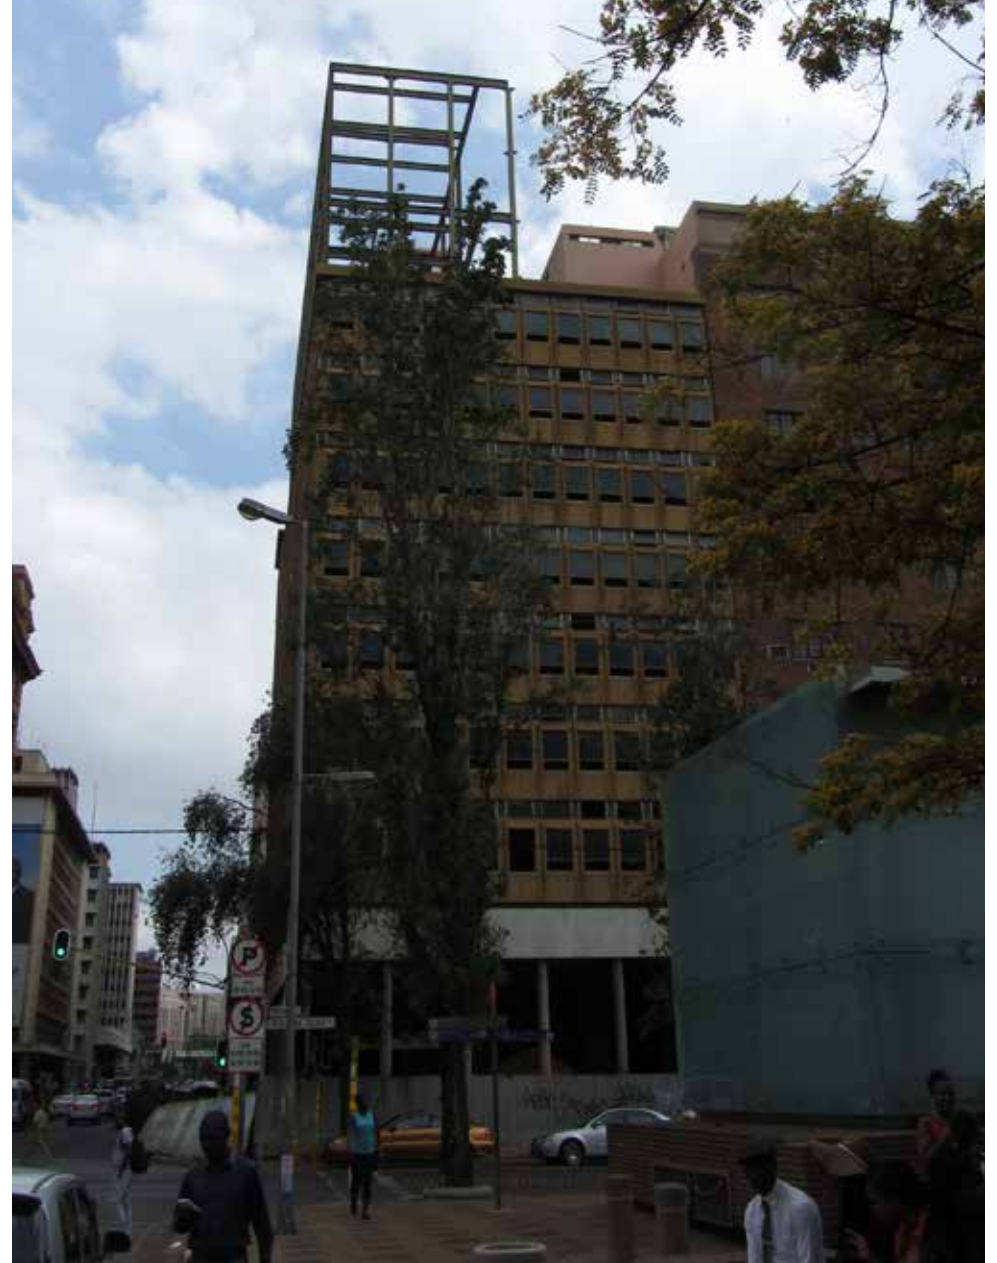
The building is currently severely vandalised, all aspects of significance have been compromised / destroyed. The building as a whole no longer merits conservation. The few remaining Eduardo Villa panels should remain (in-situ if possible) or be reused in a prominent position in the proposed new design. The height of the Volkskas building should be respected in the proposed new building. A heritage consultant should be employed to guide the design of the proposed new building or the redesign of the existing building façade. The proposed new building should take design queues from the Volkskas Building.

Contemporary image - corner facade.

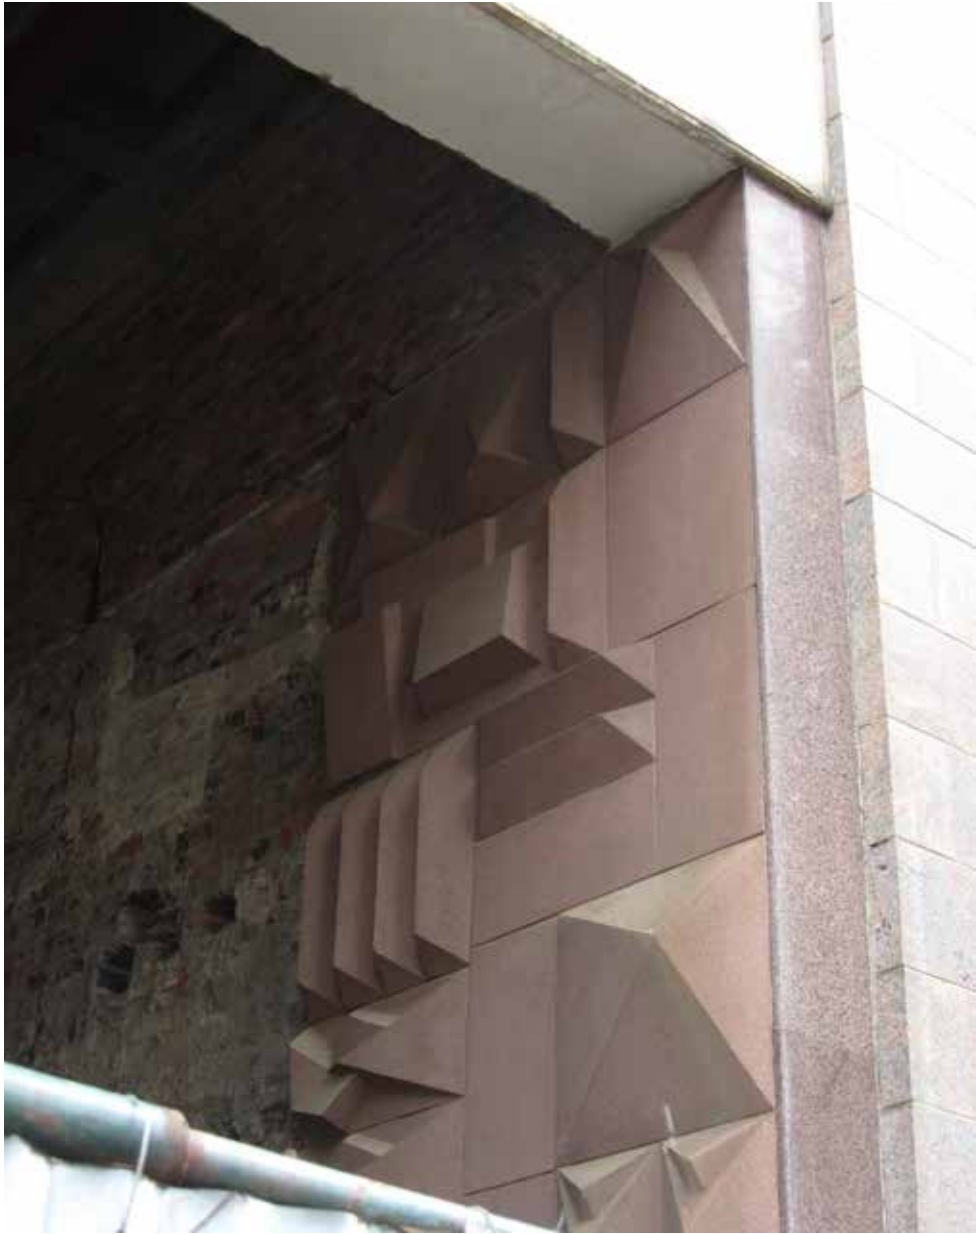
Protection:	No - structure is currently not more than 60 years old and therefore, not protected in terms of the National Heritage Resources Act.
2002 - 2015 Historical information:	Demolition proposed for 2002 Kopnong project. Granted by SAHRA. Apposed by public in 2005. Appeal upheld.
Significance:	The excellent relationship between this building and neighbouring Absa Building has been destroyed by addition of clumsy steel structure at roof height. All culturally significant aspects have been stripped / damaged beyond repair.
Section 3.3 of NHRA:	h - the other aspects have been lost.
Grading:	No cultural significance - grade to be confirmed following full heritage study
Current Condition - Exterior:	Poor.
Current Condition - Interior:	The interior is stripped, with no conservation worthy fabric remaining.
Recommendations - Exterior:	The exterior is stripped, only one small section of conservation worthy fabric remains - this is located on the edge where the building joins the Volkskas Building - a limited number of the Villa panels remain. These should be retained and incorporated into future proposed work.

Contemporary image -remaining portion of Edoardo Villa panels.

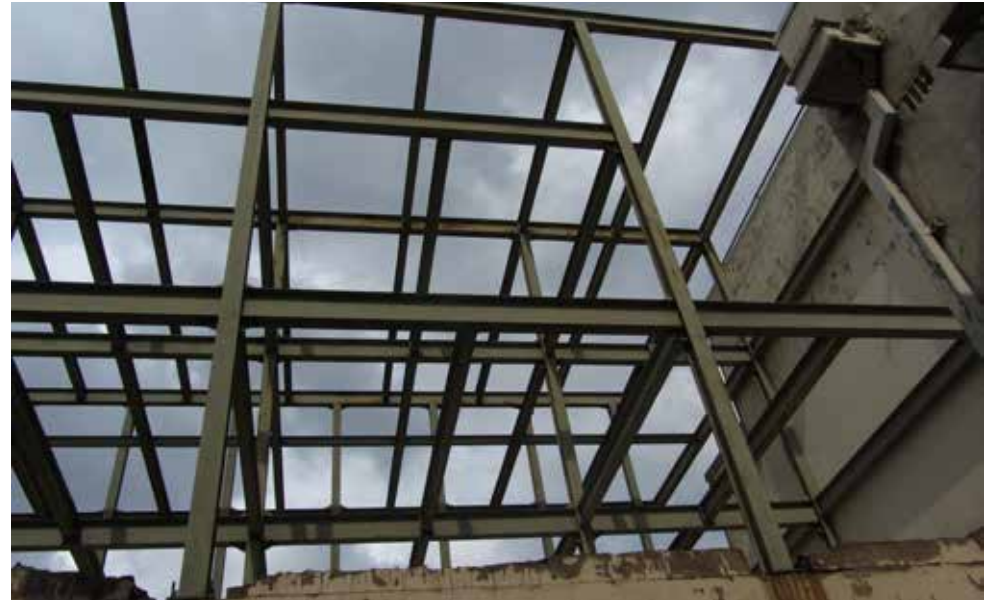
Contemporary image -detail of steel structure on roof.

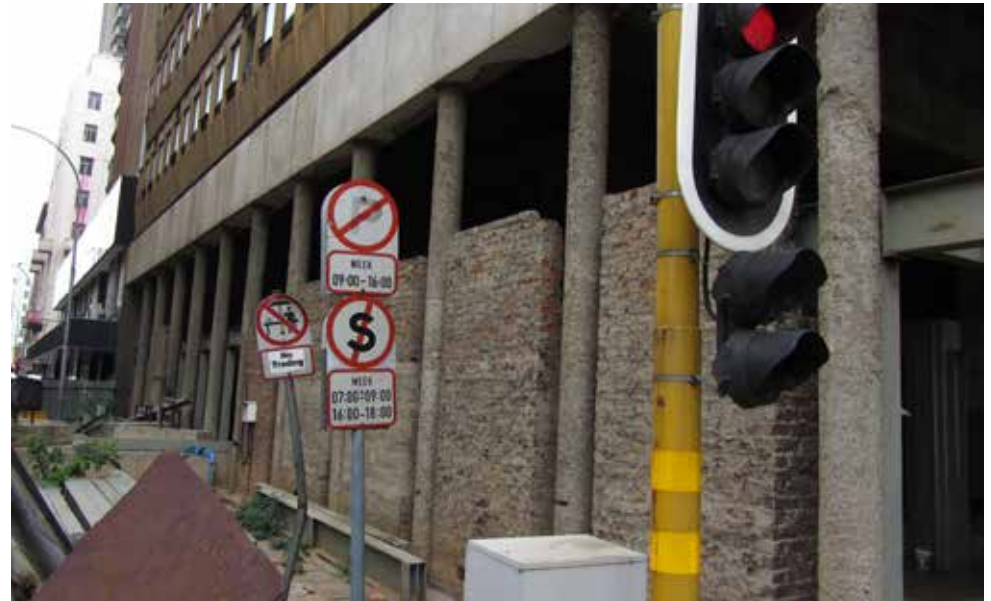
<b>6.3.14. FNB Building.</b>	
Relationship to historical aspects:	Forms a built document of the development of Johannesburg in the latter part of the 20th Century.
Social Importance:	n/a.
Modifications:	The building has been vandalised and insensitively altered to the point of being unrecognisable from its original design.
Integrity of current Structure:	The structure has been stripped and severely vandalised.
Known lost aspects or changes made:	The Eduardo Villa Panels at street level which have been vandalised beyond repair represented rare and conservation worth artistic and technical merit. The excellent relationship between this building and neighbouring Absa Building has been destroyed by addition of clumsy steel structure at roof height.
Scientific or Research Potential:	Poor, all culturally significant aspects have been stripped / damaged beyond repair.
Other:	The building originally had a sculptural façade of deeply cut precast window panels with an ochre pigment contrasting with white marble facings in a narrow-width faggots on the columns and a white marble band on the column architrave. In addition, there was a white marble transom on the narrow-width shop-fronts, white onyx floor-tiles and wall panels at the entrance. Polished red granite occurs at the recessed skirtings and recessed capitals to the colonnade, an edging theme which continued at the red granite entrance steps and the imitation granite scoreboard risers, and which echoed the polished red granite on the historic Corner House complex opposite. The sculptural panels placed between the inter-columniations on the east pavement – terracotta in colour, with relief sculpture in faceted, triangular, pyramidal and wedge shape made up out of four or five basic mould forms re-arranged in endless permutations. This was the work of Eduardo Villa in his prime, and it formed an appropriate contrast to the crisp clean details of the marble-and-glass ground floor and an anticipation, too, of the upper-level modelling. Incidentally, those sculptured ground-floor patterns are the origin of hundreds of decorative relief panels that appeared on numerous Johannesburg buildings from the 1960s to the 1980s.

Contemporary image - bricked up Ground Floor.
