## 6.3.1. Clegg House:

Gauteng Provincial Government Precinct, Johannesburg, Gauteng - Heritage Guidelines for Interested and Affected Parties - July 2017.

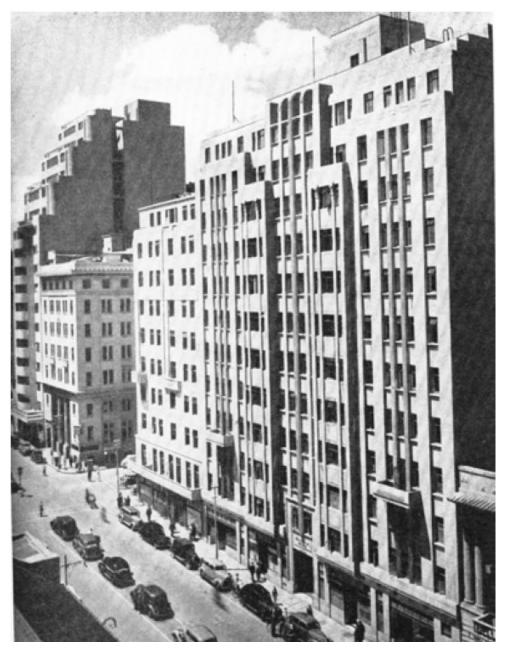
Image of Clegg House, circa 1950s - Bruwer, J. J. (2009), Clegg House (BB-3).

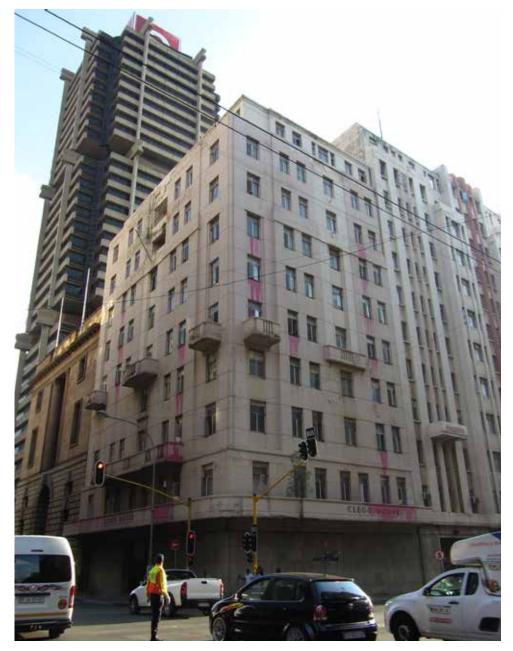
Contemporary image of Clegg House.

Protection:	Yes - structure is more than 60 years old and protected in terms of the National Heritage Resources Act.
2002 - 2015 Historical information:	Demolition proposed for 2002 Kopnong project. Granted by SAHRA. Appealed by public in 2005. Appeal declined.
Significance:	Forms part of a cohesive collection of Art Deco buildings of a similar height, style and age along the Commissioner Street cor- ridor. Holds the corner of the street well.
Section 3.3 of NHRA:	a; d; e; f; g & h.
Grading:	Culturally Significant - grade to be confirmed following full heritage study.
Current Condition - Exterior:	Fair.
Current Condition - Interior:	The interior is stripped, with no conservation worthy fabric remaining.
Recommendations - Exterior:	The fine Art Deco facades of the building form part of the historic fabric of Commissioner Street and should be retained and restored. The height and lines of the building contribute to the urban environment and street scape. The articulated roofline needs to be observed, should additional height be added this should be set back from the main facades of the building, not visible from the street. All steel windows should be retained and restored. No pop out or clip on elements are permissible on the facade. See marked up façade image.

Recommendations - Interior:	Interior does not warrant conservation.
NHRA Applications:	An application as per Section 34.1 of the NHRA is required.
Recommendations - Overall:	The exterior architecture and facades hold high heritage value and should be conserved and restored, the interiors are largely stripped and offer little in terms of cultural significance, conservation worthy fabric or provenance. Steel windows should be retained and no "pop outs" allowed. The roofline should be observed.
