# JOHANNESBURG METROPOLITAN MUNICIPALITY

# HERITAGE ASSESSMENT SURVEYING FORM

NAME OF PLACE: ROEHAMPTON COURT

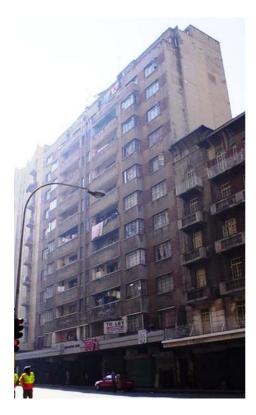
Main photo: view of main (Bree Street) façade.

Right, top: view of section of main façade, showing the decorative panels to the Second Floor balconies. The *Dunvegan Chambers*, completed two years before the *Roehampton Court*, and designed by J.C. Cook & Cowen, the architects of the latter building, has quite similar decorative panels. Right centre: seen in this photo taken from a position opposite the *Edward House* in Loveday Street, is the 1939 addition.

Right, bottom: from left to right in Bree Street – *Dorchester Mansions, Roehampton Court,* and *Lawson Mansions*.

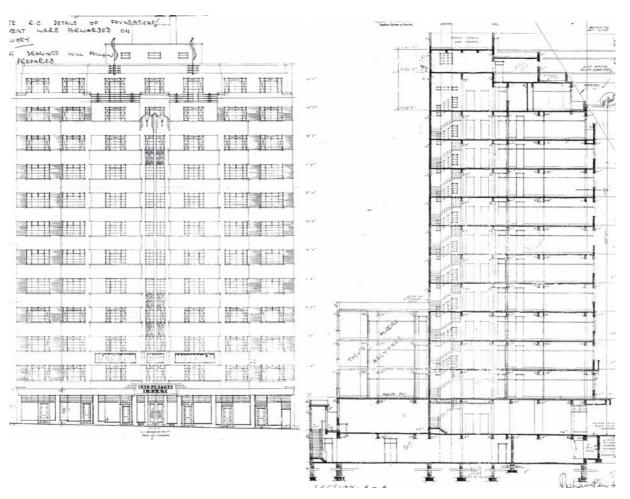
Below: extracts from original submission drawings prepared by the architectural practice of J.C. Cook & Cowen in 1934. Revised Floor Plans that were subsequently prepared are dated 9 May 1935. Left: copy of front (Bree Street) elevation. Right: section.

Completed at the beginning of 1936, this multi-storey Art Deco building was designed by the well-known architectural firm of J.C. Cook & Cowen. Some of its notable features (shared by many other apartment buildings from the period of its construction) are as follows: the aspect of mass articulation in the central section of the main façade (e.g. projecting thin vertical bands, projecting balconies with rounded corners, corner windows, and decorative panels to the Second Floor balconies); the replication in layout of most of the residential floors of the building (viz. First to Tenth Floor). Of interest also, is the stepped-back treatment in the form of the building from the Tenth Floor up.
