JOHANNESBURG METROPOLITAN MUNICIPALITY

HERITAGE ASSESSMENT SURVEYING FORM

NAME OF PLACE: WISE MART BUILDING

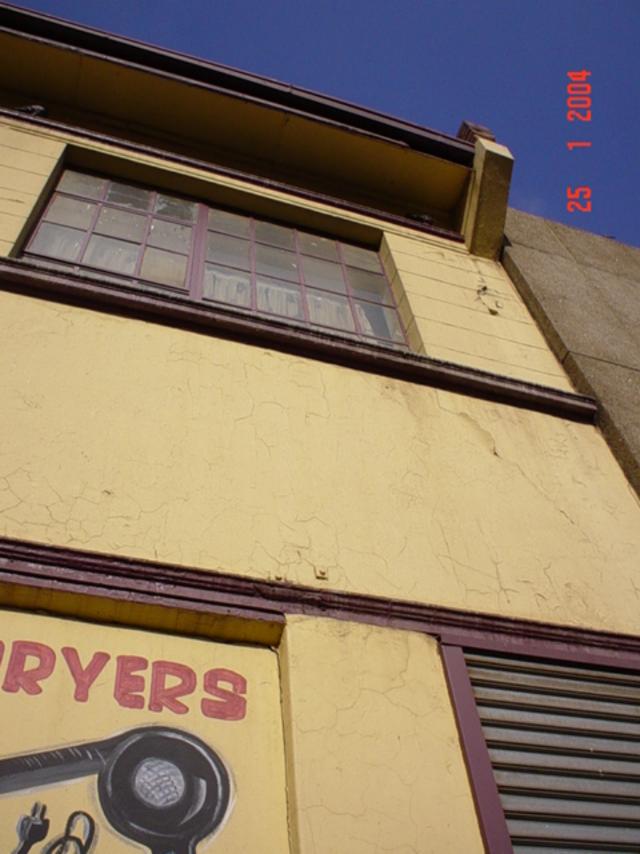
Top right: façade detail. Bottom left: Jeppe Street elevation. Bottom right: situated in the middle-background is the *Wise Mart Building, 'hemmed-in'* by the *Triad Buildings,* in the right foreground, and the *FNB Bank City Complex* in Jeppe Street.

Noteworthy features of the building are the wide eaves with extended gable walls; two string courses defining the middle section of the façade and the fenestration on Jeppe Street (compare with Fraser Street elevation).
