**JOHANNESBURG METROPOLITAN MUNICIPALITY**

**HERITAGE ASSESSMENT SURVEYING FORM**

**NAME OF PLACE: GENERAL HOUSE**

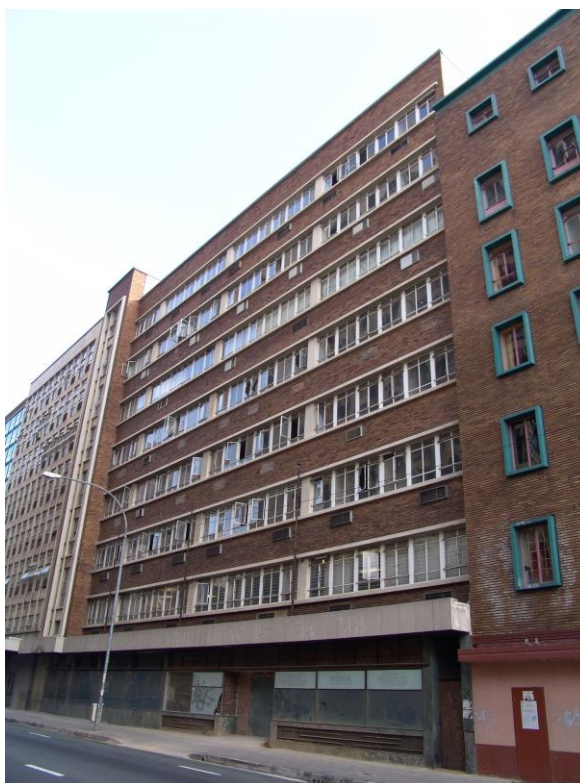
Above: View of the main façade of the building.

The building stands derelict and neglected. The effect of changes (some of which, however, appear to be reversible, e.g. bricked-up sections) to the shop front of the building, has been to compromise the aesthetic qualities of the design of the main façade of the building. The removal of polished granite panels, adorning the façade at street level, is a concern. So also is the problem of broken windows.

Although not protected under the current heritage legislation (i.e. the building is not older than 60 years), the building has architectural merit, and the problem of its neglected condition, should therefore receive attention.
