### 6.3.14. FNB Building.

Gauteng Provincial Government Precinct, Johannesburg, Gauteng - Heritage Guidelines for Interested and Affected Parties - July 2017.

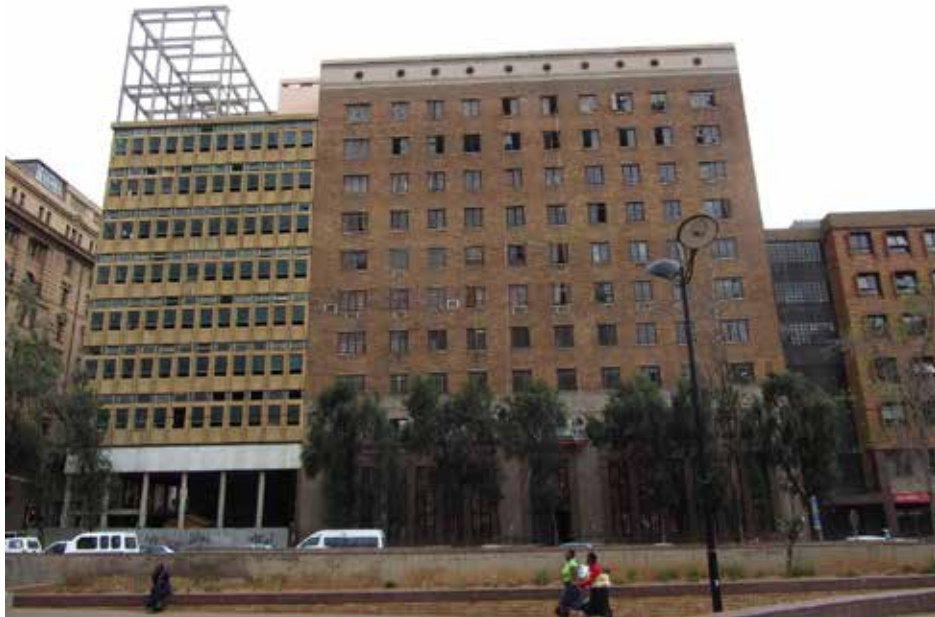
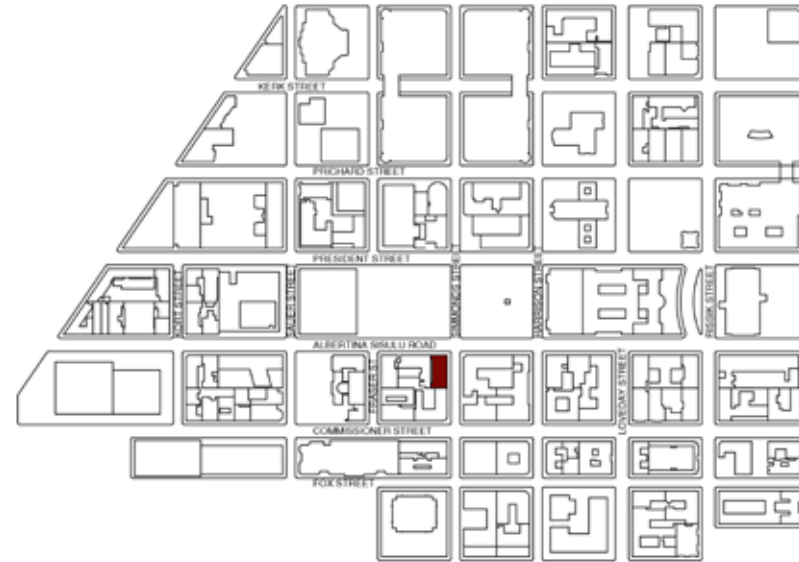
<b>6.3.14. FNB Building.</b>	
Relationship to historical aspects:	Forms a built document of the development of Johannesburg in the latter part of the 20th Century.
Social Importance:	n/a.
Modifications:	The building has been vandalised and insensitively altered to the point of being unrecognisable from its original design.
Integrity of current Structure:	The structure has been stripped and severely vandalised.
Known lost aspects or changes made:	The Eduardo Villa Panels at street level which have been vandalised beyond repair represented rare and conservation worth artistic and technical merit. The excellent relationship between this building and neighbouring Absa Building has been destroyed by addition of clumsy steel structure at roof height.
Scientific or Research Potential:	Poor, all culturally significant aspects have been stripped / damaged beyond repair.
Other:	The building originally had a sculptural façade of deeply cut precast window panels with an ochre pigment contrasting with white marble facings in a narrow-width faggots on the columns and a white marble band on the column architrave. In addition, there was a white marble transom on the narrow-width shop-fronts, white onyx floor-tiles and wall panels at the entrance. Polished red granite occurs at the recessed skirtings and recessed capitals to the colonnade, an edging theme which continued at the red granite entrance steps and the imitation granite scoreboard risers, and which echoed the polished red granite on the historic Corner House complex opposite. The sculptural panels placed between the inter-columniations on the east pavement – terracotta in colour, with relief sculpture in faceted, triangular, pyramidal and wedge shape made up out of four or five basic mould forms re-arranged in endless permutations. This was the work of Eduardo Villa in his prime, and it formed an appropriate contrast to the crisp clean details of the marble-and-glass ground floor and an anticipation, too, of the upper-level modelling. Incidentally, those sculptured ground-floor patterns are the origin of hundreds of decorative relief panels that appeared on numerous Johannesburg buildings from the 1960s to the 1980s.

The building is currently severely vandalised, all aspects of significance have been compromised / destroyed. The building as a whole no longer merits conservation. The few remaining Eduardo Villa panels should remain (in-situ if possible) or be reused in a prominent position in the proposed new design. The height of the Volkskas building should be respected in the proposed new building. A heritage consultant should be employed to guide the design of the proposed new building or the redesign of the existing building façade. The proposed new building should take design queues from the Volkskas Building.

Protection:	No - structure is currently not more than 60 years old and therefore, not protected in terms of the National Heritage Resources Act.
2002 - 2015 Historical information:	Demolition proposed for 2002 Kopnong project. Granted by SAHRA. Apposed by public in 2005. Appeal upheld.
Significance:	The excellent relationship between this building and neighbouring Absa Building has been destroyed by addition of clumsy steel structure at roof height. All culturally significant aspects have been stripped / damaged beyond repair.
Section 3.3 of NHRA:	h - the other aspects have been lost.
Grading:	No cultural significance - grade to be confirmed following full heritage study
Current Condition - Exterior:	Poor.
Current Condition - Interior:	The interior is stripped, with no conservation worthy fabric remaining.
Recommendations - Exterior:	The exterior is stripped, only one small section of conservation worthy fabric remains - this is located on the edge where the building joins the Volkskas Building - a limited number of the Villa panels remain. These should be retained and incorporated into future proposed work.

Recommendations - Interior:	Interior does not warrant conservation.
NHRA Applications:	An application as per Section 34.1 of the NHRA is required if work is proposed to the building after 2018.
