JOHANNESBURG METROPOLITAN MUNICIPALITY

HERITAGE ASSESSMENT SURVEYING FORM

Compiled by: Dr JJ Bruwer, 2002-07-29

NAME OF PLACE: MILADY'S BUILDING

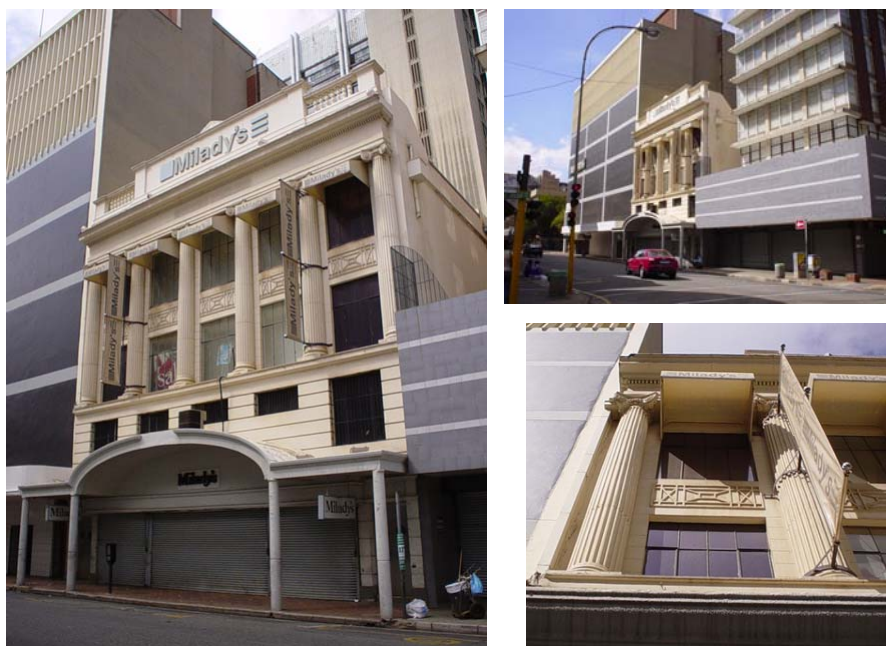
Main photo: view of main (President Street) façade. Top right: Top right: from left to right – Truworths Building, Milady's Building and City Centre.

Noteworthy features of the building include the six giant-order fluted Ionic columns supporting a gabled parapet wall with moulded balustrades and embossed lettering, and entablature with dentil insets; an exceptional segmental arched verandah hood to the double volume ground floor with large

display windows and stucco plaster; and the striking moulded plaster work appearing on the wide horizontal bands between the giant-orders.

This building has retained almost all of its original external elements; the two large flag masts have been removed and the building's original name *Henderson's* to the gabled parapet wall, was changed to *Milady's*.

Good.
