JOHANNESBURG METROPOLITAN MUNICIPALITY

HERITAGE ASSESSMENT SURVEYING FORM

NAME OF PLACE: FLEETWAY HOUSE

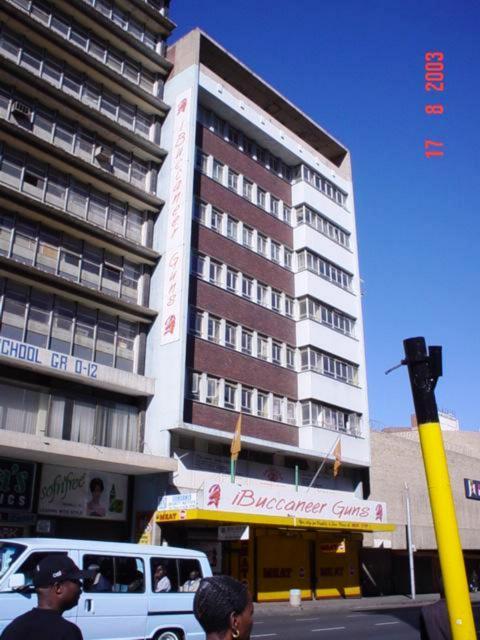
Left: view of Bree Street elevation.

Top: the building as seen from a position in Bree Street, northeast of the neighbouring *second Standard House*.

Walls: face brick.

Roof:	flat, concrete.
Windows:	steel side-hung casements.
Good example positioned on the	of Early Modernist building with strong horizontal lines, of interest is the two flagpoles ne balcony.
SITE FEATURE	ES:
ALTERATIONS	3 :
INTEGRITY:	
INSCRIPTION	:
ARCHITECT:	
Colly Segal.	
BUILDER:	
CONSTRUCTIO	ON DATE:
Date on plans Approval of plan Completion date	: ns : 21 August 1951 e : 30 November 1954
BUILDING ST	YLE:
Early Modernist	
BUILDING TY	PE:
ENVIRONMEN	Т:
(sic). Moreover as was shown individualistic to a low-rise environment, it constructed next.	of this period were put up flush with the pavement and on a rectangular groundplar, the economic interests of the individual were more important than the overall aspect by the differentials of height and façade articulations of the buildings. The highly reatment of buildings was particularly disturbing in the case of tall buildings erected in ronment. Such buildings had unfinished lateral sides in which the light-coloured grid reinforced concrete frame was in sharp constrast [sic.] to the filled-in unplastered reconstrated the buildings not only betrayed a marked insensitivity to the visual aspect of the buildings had unfinished lateral optimism of the owners (that other buildings at door would soon make good the impairment of the general aspect) as well as their historical building corpus of the city." (Van Der Waal, G-M.: From Mining Camp to

CONDITION:	
Good.	
URGENT ACTI	ON:
SAHRA RECOR	RD REGARDING ALTERATIONS, RENOVATIONS, RESTORATION:
PROTECTION	STATUS: (under National Heritage Resources Act, 1999)
General protectio	n: Section 34(1) structure/s
Formal protection	n: provincial heritage site
	national heritage site
	provisional protection
	heritage area
