9.1 Double storey educational facilities_Maryvale College_Stand 79

Address	10 St. Mary's Road
Stand No.	79
Current Zoning	Educational
Year of erection	1939
Architect	Unknown
Heritage Significance	Architectural
Statement of Significance (Heritage importance grading system due to the National Heritage Resources Act 25, 1999)	(a) its importance in the community, or pattern of South Africa's history;
Proposed SAHRA Grading	3A

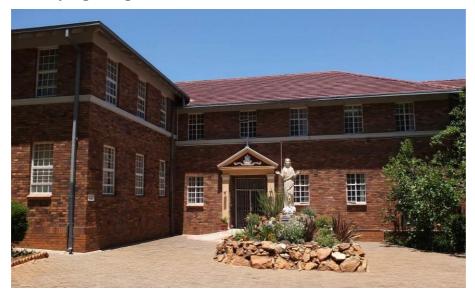
Fig. 191 School buildings consists of double storey face brick buildings with low pitched tiled roofing and classical decorative elements around the main entrance (Source: tsica heritage consultants, 2015)
